Manhole Inspection Summary

Manhole # S09MM1010MH

Location Address: **4830 WILERN AVE**

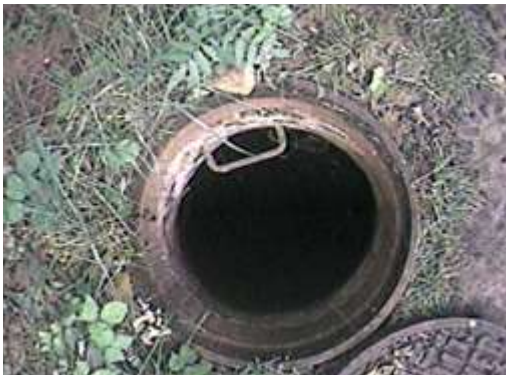
Defect 1

Frame Offset: **1** (in.) Condition: ☒ Sound ☐ Cracked ☐ Leaks

FRAME OFFSET

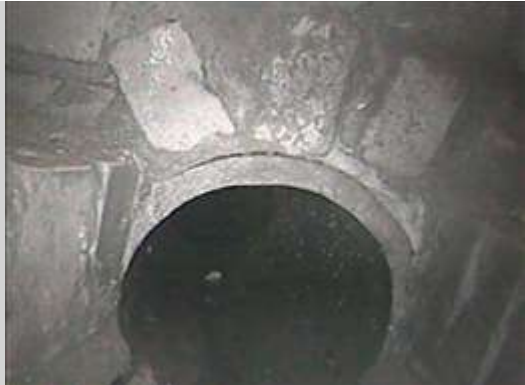
12 O'Clock Outflow

8 in. Circular Gravity Sewer
Pipe Out @ 12 O'Clock

Pipe Height: (in.) Direct
Pipe Material: **Clay** ☐ Pipe Lined
Invert Depth: **10.17** (ft.) Flow Characteristics: **Slow**
Deposits: ☒ None ☐ Mud ☐ Sludge ☐ Debris ☐ Grease
Silt Depth: (in.) Deposits Extent:
Infiltration: **None** Pipe Seal Cond: **Sound**

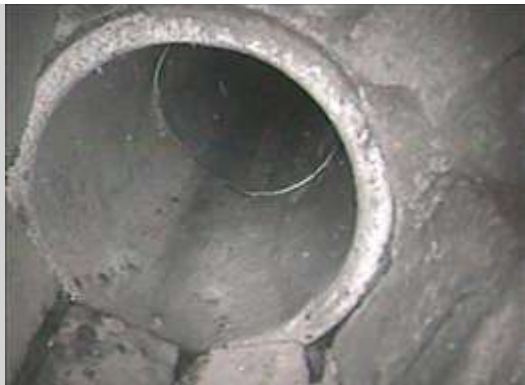
9 O'Clock Inflow

6 in. Circular Gravity Sewer
Pipe In @ 9 O'Clock

Pipe Height: (in.) Direct
Pipe Material: **Clay** ☐ Pipe Lined
Invert Depth: **9.97** (ft.) Flow Characteristics: **Slow**
Deposits: ☒ None ☐ Mud ☐ Sludge ☐ Debris ☐ Grease
Silt Depth: (in.) Deposits Extent:
Infiltration: **None** Pipe Seal Cond: **Sound**
